# Release Note for AlliedWare Plus Software Version 5.5.4-2.x

## AlliedWare Plus OPERATING SYSTEM

» 5.5.4-2.3 » 5.5.4-2.4 » 5.5.4-2.5

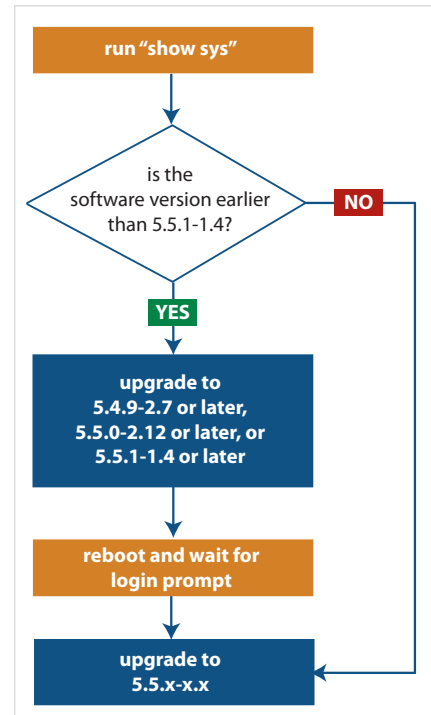
To see your current firmware version, check the “Software version” field in the command:

```
awplus# show system
```

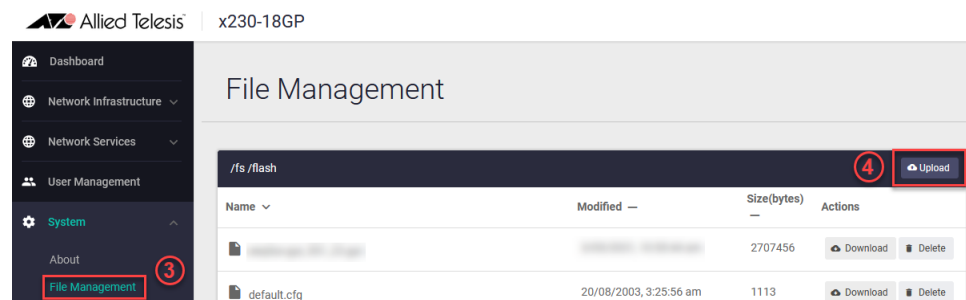
3. Go to **System > File Management**

4. Click **Upload**.
