## AlliedWare Plus Software Version 5.5.5-1.x

- AMF Plus Cloud
- SBx81CFC960
- SBx908 GEN2
- x950 Series
- x930 Series
- x550 Series
- x540L Series
- x530 Series
- x530L Series
- x330 Series
- x320 Series
- x250 Series
- x240 Series
- x230 Series
- x220 Series
- IE360 Series
- IE340 Series
- IE220 Series
- IE210L Series
- SE540L Series
- SE250 Series
- SE240 Series
- XS900MX Series
- GS980MX Series
- GS980EM Series
- GS980M Series
- GS970EMX Series
- GS970M Series
- 10GbE UTM Firewall app
- ARX200S Series
- AR4000S-Cloud
- AR4050S-5G
- AR4050S
- AR3050S
- AR1050V
- TQR Series

5.5.5-1.2, 5.5.5-1.3, 5.5.5-1.6

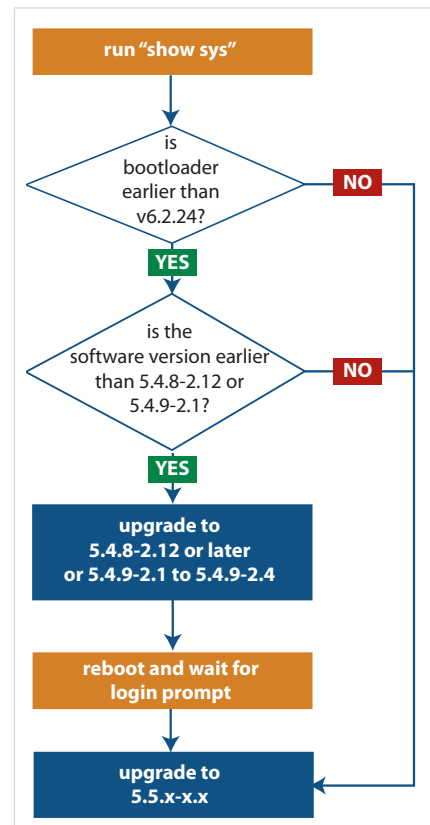
To see your bootloader and current software version, check the "Bootloader version" and "Software version" fields in the command:

```
awplus# show system
```

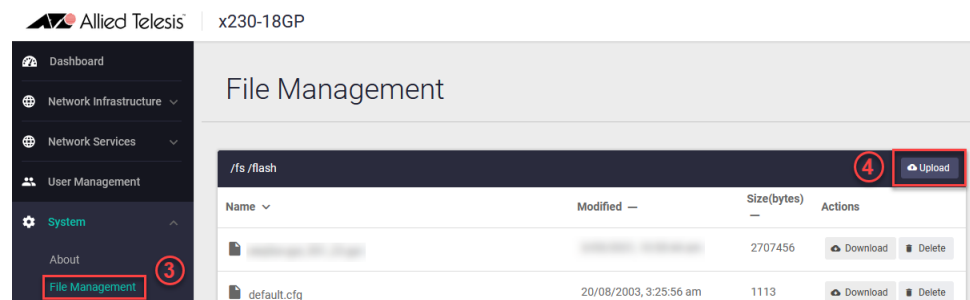
3. Go to **System > File Management**

4. Click **Upload**.

5. Locate and select the GUI file you downloaded from our Support center. The new GUI file is added to the **File Management** window.
