Software Maintenance Release Note

AlliedWare Plus™ Software Version 5.4.6-2.12

For SwitchBlade x8100, SwitchBlade x908, DC2552XS/L3, x930, x610, x510, IE200, IE300, IE500 Series Switches, IX5, x310, x230, x210, FS980M, GS900, and XS900 Series Switches, AR2010V, AR2050V VPN Firewalls, AR3050S and AR4050S NGFWs, and VAA.

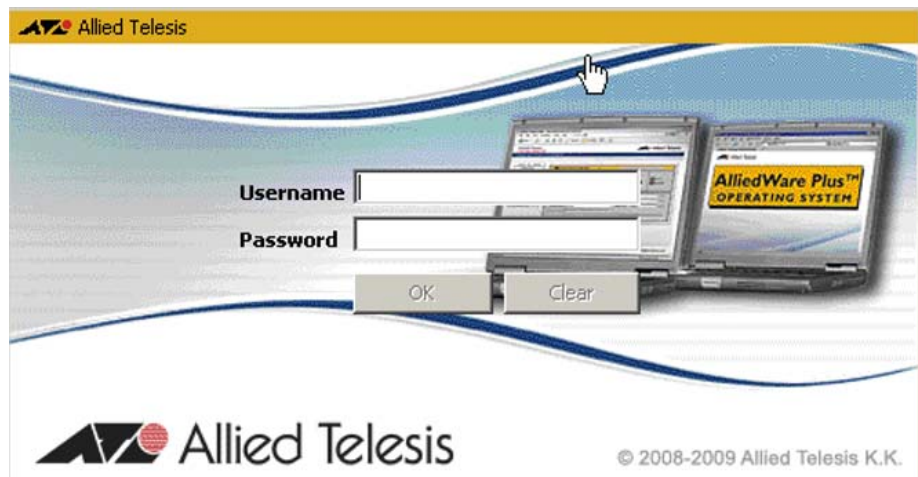
9. Log into the GUI.

Start a browser then enter the IP address you configured in Step 3 as the URL. You will then be presented with a login screen after the GUI Java applet has started. You can then Log in with the username and password that you defined previously in Step 6.
